# Troubleshooting\_Injection

# Troubleshooting Examples

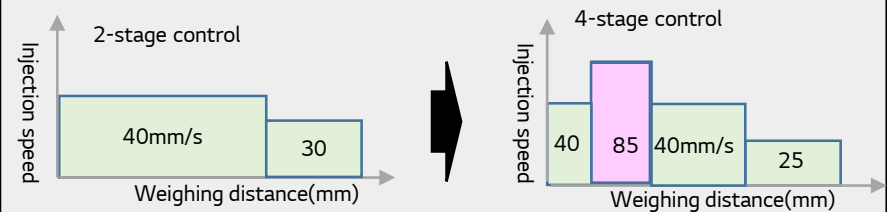
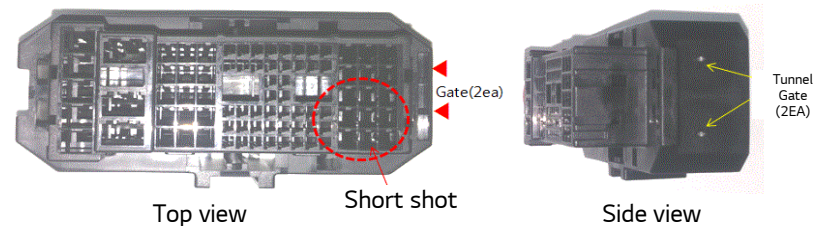
Hybrid Connector, LUPOX GP1000K

- Fundamental improvement plan :  
Equalize the thickness of products
- Multi-stage control of injection speed  
→ Increase speed at thin part

- Result : Short shot problem solved

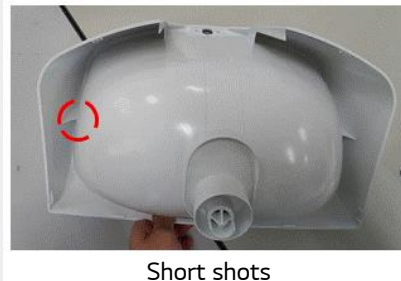
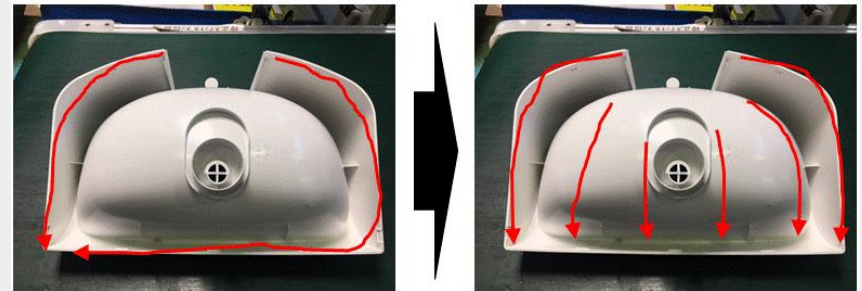
Bathroom vanity parts, ABS AF365FT

- Short shot during injection process
- Adjusting injection condition did not help solving the problem

- Flame Retardant ABS has high flowability, but generates large amount of gas.
- Gas generated at the end of the flow is expected to result low stagnation.

- Add gas vents on the rib area, where short shot occurs
- Adjust flow balance by adding gas vents at the end, and by changing the thickness of product

Change flow pattern by changing thickness

- Result : Resolved short shot & weld-line problem
- If adjusting injecting condition does not work, it is necessary to consider mold modification to solve the problem.

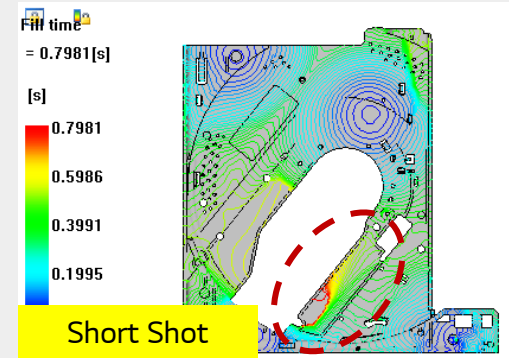
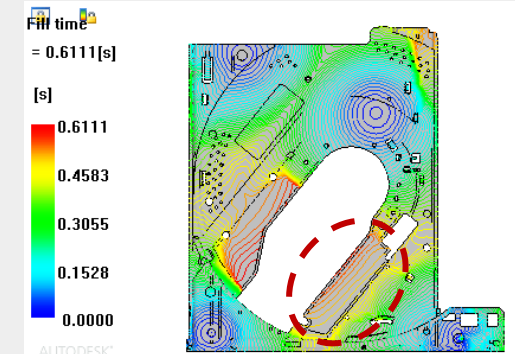
Relocated the Gate

- Change gate position (From thin to thick part)  
→ Short shot problem resolved

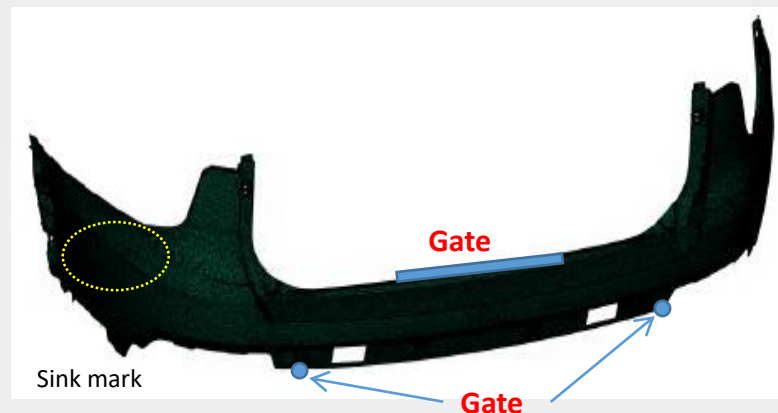
Auto Bumper, LUPOX TE5011

- Sink mark occurs at the farthest area from the gate of large items (bumper C side)
- In-situ reaction :  
If injection pressure & packing pressure are increased, the sink does not resolve but caused burr & peeling because of overpressure near the gate.

- The pressure cannot be delivered to the farthest area from the gate due to the long flow path  
→ Increase flowability to improve pressure delivery

- Adjust injecting condition in order to deliver sufficient pressure to the farthest area of the product
  - Increase injection speed/ temp. if allowed
  - If necessary, set up the flow leader
  - Change the position of the gate or suggest to increase the gate size

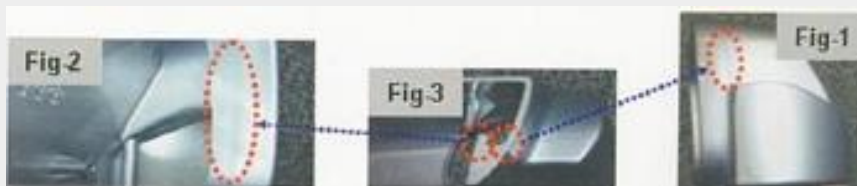
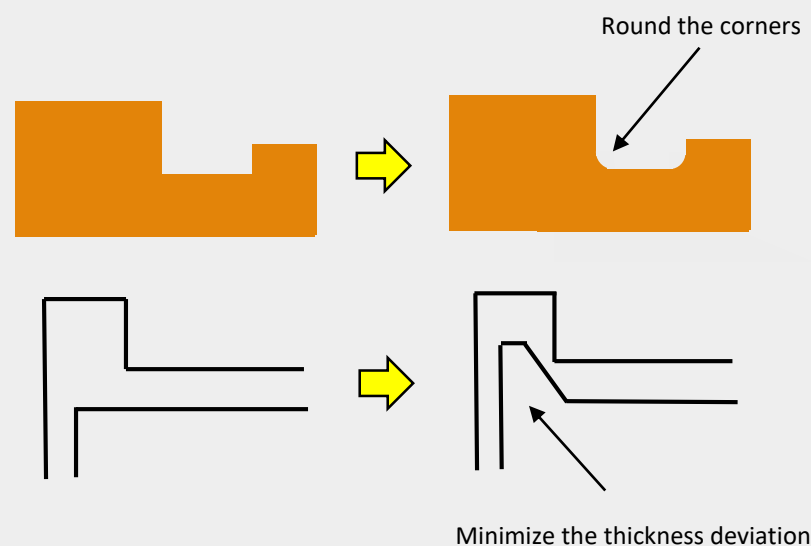
- Shrinking observed both inside and outside of the product
- As shown in the figure below, mold was designed thick, so pressure could not be delivered sufficiently.

- Enlarge cross-sectional area of the sprue/ runner/ gate to relieve pressure loss
- Minimize the thickness deviation
- Set up the R value

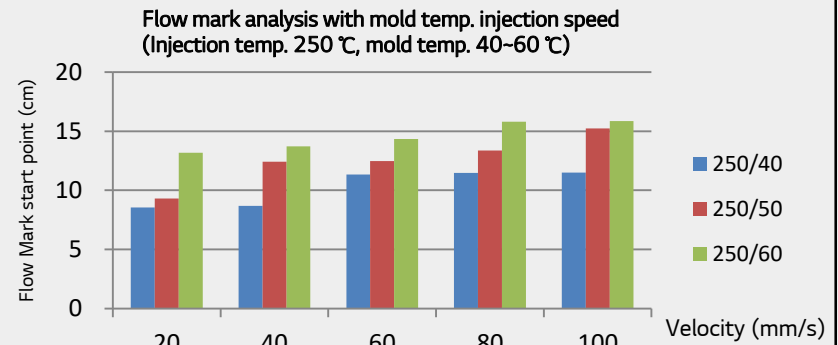
Wide Spiral, ASA L1941

- Defect caused by uneven flow of material

\*\*If mold temp. increases, the start point of the flow mark is pushed back.

- Increasing injection speed and mold temp. would help to resolve the problem.

- Higher flowability might relieve the flow mark

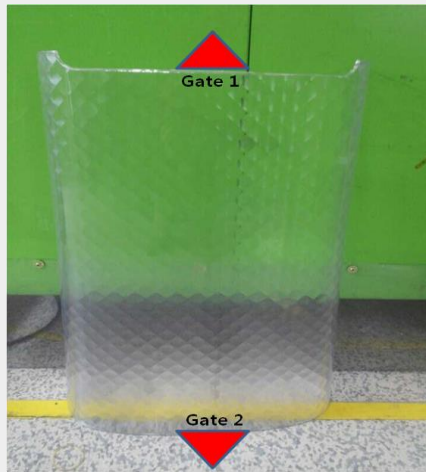
~1000mm  
Large-sized part

- Surface Flow mark

- To reduce the flow mark, apply multi-stage injection speed, and lower the overall speed at the same time : 30~40mm/s → 15mm/s
  - To prevent decrease in flowability, increase the injection temperature : 240 °C → 245°C
- Result : After continuous 600-shot test, 1% of defect rate was observed in mass production.

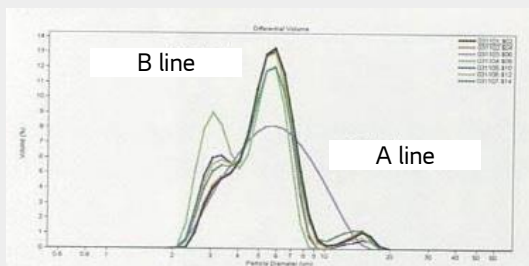
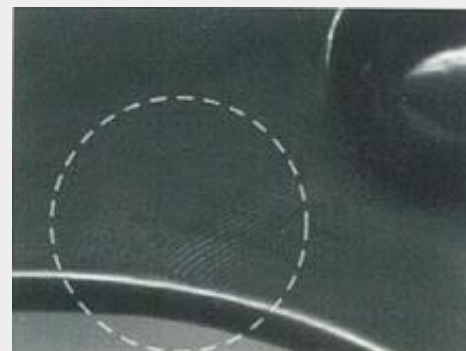
- Flow mark occurred on the exterior of copier cartridge, which used HIPS
- Observed severe flow mark and partial surface gloss defect in certain LOT
- No special issues with injection conditions

- After tracking base resin LOT, could figure out that there was rubber size deviation between each LOTs

- If the rubber size of the product is big, decomposition and flow degradation occurs when the shear is excessive, resulting poor surface quality.
- Lowering injection speed and increasing mold temp. help to decrease shear rate.

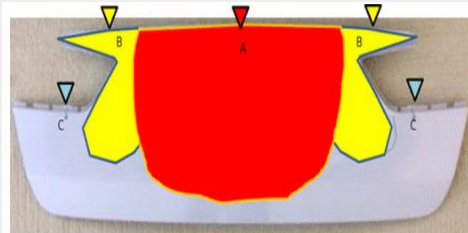
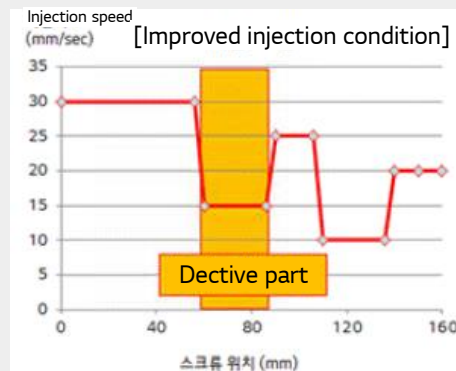
Silver streak

Back Panel, ABS XR404E

- Material filled from gate B solidified near the gate C
- If material is filled from gate C, solidified resin from gate B re-melts, which causes cold slugs
- When the resin of gate C is filled, the speed is fast

- Change the gate C opening time :  
Set within the range where no solidified layer is created near gate C (Reduce valve open delay time)
- Apply multi-stage injection speed :  
Reduce the injection speed from the point where the resin starts to be filled through gate C to the point where the defect occurs

Resolved

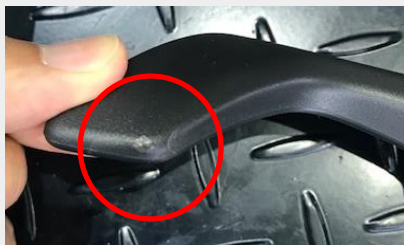
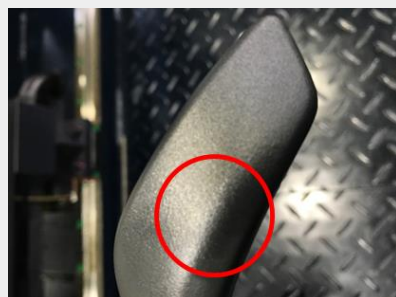
- Air trap occurred near the surface
- Visual defect observed on the upper matt part

- Air trap occurs due to flow pattern during injection due to product structure
- Lack of gas vent even the injection speed is high
- Degradation gas due to high resin temp.

- Apply multi-stage injection to reduce injection speed near the defective part, which allows filling without air trap to the end and gives enough time for gas venting
- Prevent thermal decomposition by reducing the cylinder residence time of resin through weighing delay
- Injection condition change
  - Terminal speed 30 mm/s → 7 mm/s
  - Cylinder residence time 10 sec → 1 sec
- Result : Air trap defect solved

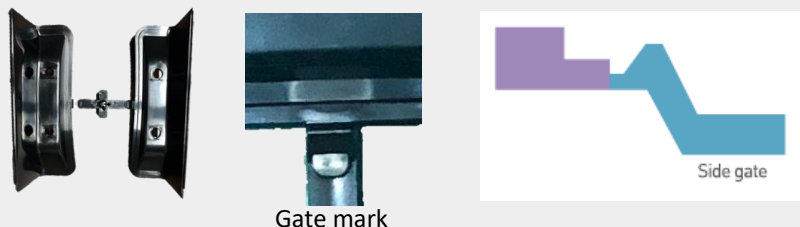
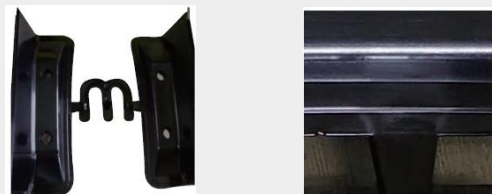
- Surface is important as a non-painting product
- Gate mark appeared near the gate

- Processing window was narrow due to UV-stabilizer in the material
- If injection speed adjusted 3%↓, gate mark problem is solved but flow mark appeared
- Gate was set at the thin part (1T) and there was a step difference between gate and the product. And due to the narrow width of the gate, it gets high shear stress

- Gate design change
  - Remove step difference, widen the gate width
  - Suggest runner design change (I type → C type)
  - If gate structure is changed, Max. shear rate decreases from 11,000 1/s to 1,760 1/s
- After changing runner design & step difference: Gate mark and flow mark defect was resolved because processing window ↑

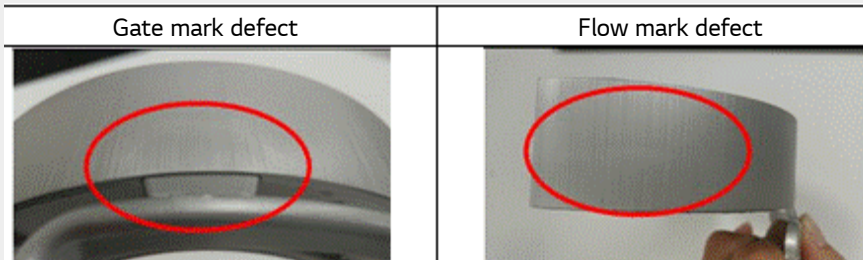
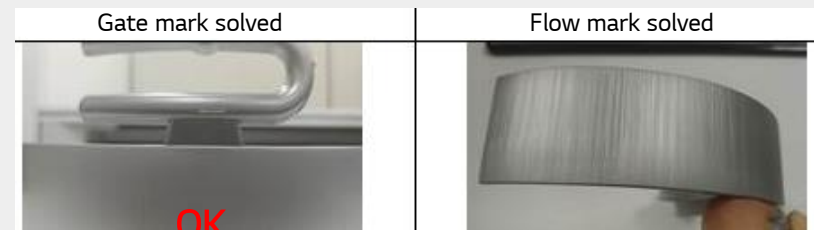
Water purifier machine Top cover, ASA LM915

- Surface quality was important because it is non-painting top cover product
- Semi-circle shaped gate mark occurred the product

- Step difference between gate and the product.
- Both LGC's material and competitors' had same problem but customer didn't want to change the mold system.

- Adjust injection condition
  - 1<sup>st</sup> step (Gate) (24mm/s → Multi : 6~16mm/s)
  - 2<sup>nd</sup>~4<sup>th</sup> step (Main) : 11 mm/s
  - 5<sup>th</sup> step (End) : 16mm/s
  - Packing pressure : 30(1) → 80(5) Mpa (sec)
- Result : Sink mark, Gate mark defect solved

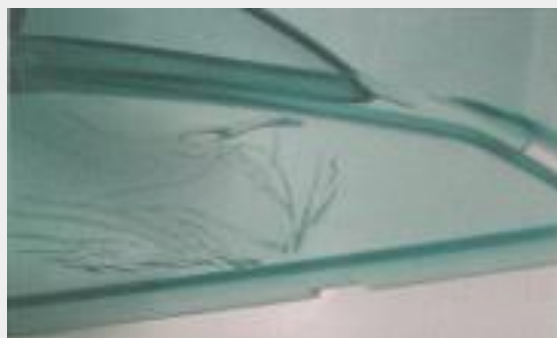
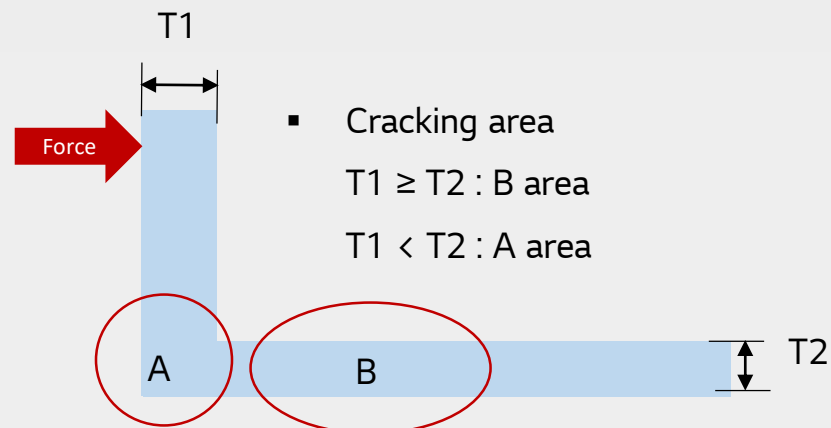
- Crack at washing machine top cover, which applied transparent ABS

- Crack occurs in transparent ABS after assembly with GP ABS
- Cracks due to residual stress because of thickness deviation

- Cracking area  
 $T1 \geq T2$  : B area  
 $T1 < T2$  : A area

- This product :  $T1 = 2.5\text{mm}$ ,  $T2 = 2.3\text{mm}$ 
  - Crack occurred in B area
  - Changed T2 thickness to 2.5mm
  - Round the corner of A area

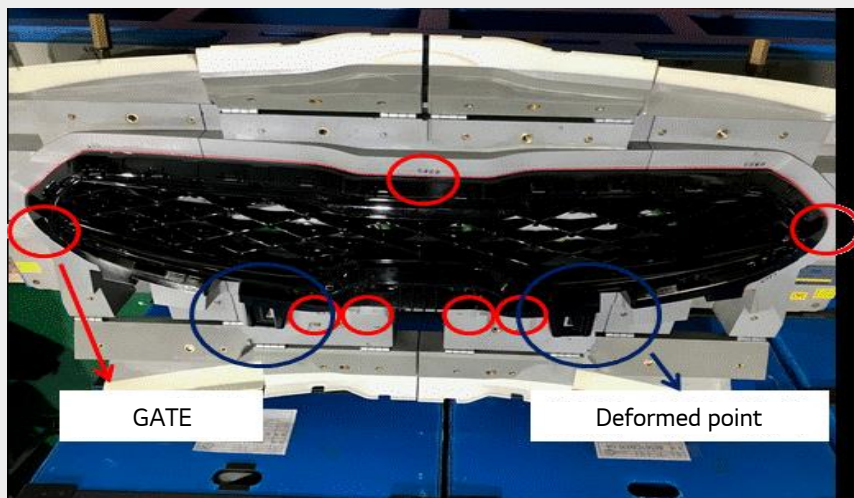
- Lifting at the centre part of the product
- NG due to deformation of several specific areas shown below, while assembly

- Lifting occurs due to excessive deformation of a long product in a transverse direction
- Stress is concentrated due to high injection pressure as there are a large number of gates in the area where deformation occurred

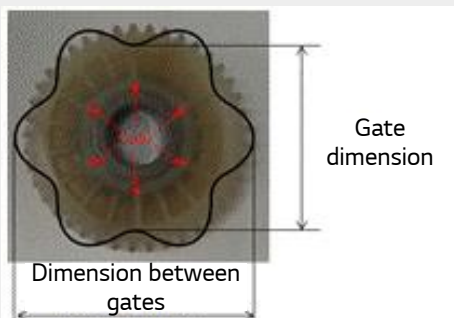
- Dimensional difference occurred between the gates

- Solidifying part before VP switching lead uneven pressure transmission
- Filling by packing pressure, not the injection pressure (VP switch starts at 80% filling)
- Uneven pressure at the end of the product

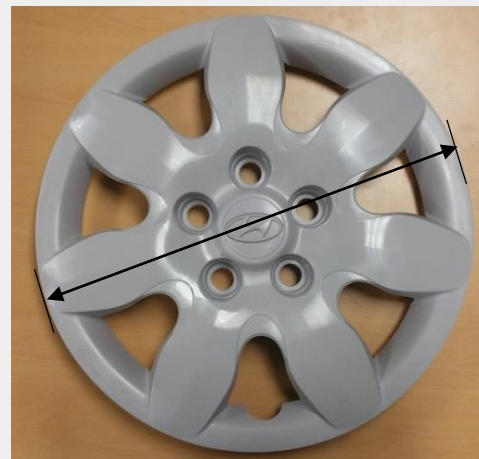
- Additional shrinkage was found after painting (Post-processing)
- Increasing temperature causes burr because it reduces flowability

- Decrease injection temp. (290 °C → 270 °C), mold temp. (80 °C → 40 °C)
- Increased packing pressure to meet the weight spec
- Result : Size, weight OK

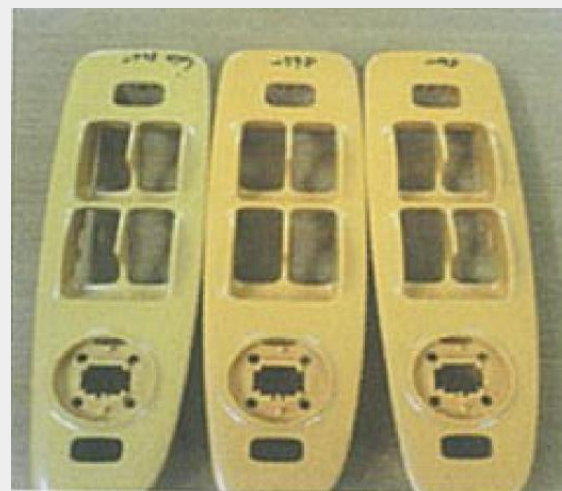
Window switch frame, Heat resistant ABS

- Difference in color tone between main part and the assist part
- Defects occur after 10<sup>th</sup> cycle of production

- It is OK right after purging all the material, but defects occur again soon
  - Problem occurs in the barrel
- If there's a problem in the barrel temp. and weighing condition, material deformation causes color, surface defects
  - Need to check the actual temp.

- Heater 1 temp. was 500 °C, and this was figured out after checking the actual temp.  
(Set temp. : 240°C)
- Repair Heater 1

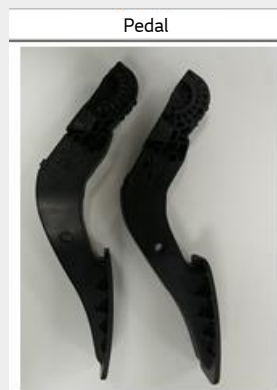
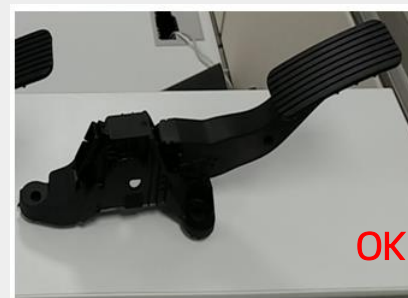
Clutch Pedal, LUMID GP2400AW

- High injection temp. (PA66's condition)
- Pedal : Ejecting before enough cooling
- Housing: No gas vents at the end of the product

- Pedal : Adjust injection temp.
  - Temp(°C) : 320 → 280
  - Cooling time(s) : 15 → 25
  - Ejecting speed(%) : 40 → 30
- Housing : Mold change
  - Set up a overflow
- Result : Ejecting pin mark, Gas mark Improved

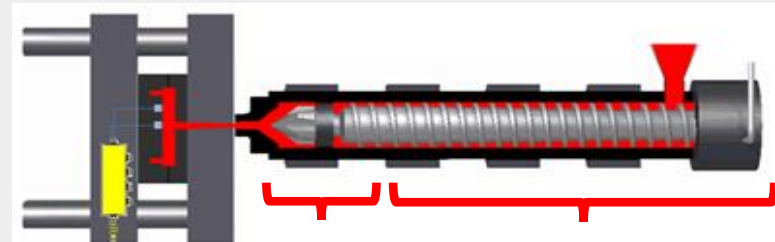
<Actual injection volume ~30mm> <Temp. decrease around 20~30°C>

- Large injection machine is used because it is a 47inch TV front cover, but the actual injection volume is so small and staying time long (Use 30mm out of 600mm barrel size)
- The size of hot runner and manifold is big, which makes material stay longer in a mold
- Plasticizing condition are not optimized yet.

- Partial temp. drop excluding the actual injection volume of the cylinder

- Adjust injection condition
  - Back pressure 0 bar → 10~15 bar
  - RPM 50 % → 30 %
  - Set weighing delay time 0 sec → 22 sec
  - Decrease cushion 16mm → 3~5mm
- Result : No mold-deposit more than 24hours

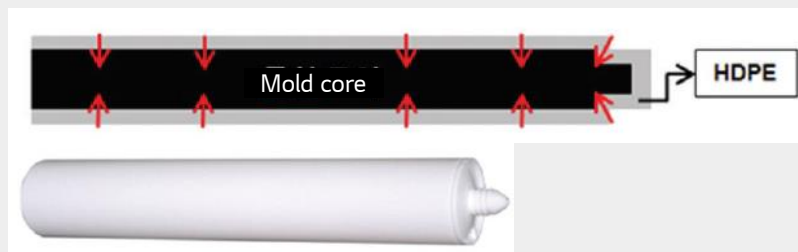
- Suggested new products, which have higher fluidity
- As the flow improves, the resin is filled more under the same injection conditions, and the material gets trapped in the mold core.

- MI was same before and after (Catalyst change)
- To observe viscosity change in a high shear area, fluidity test was done in a same screw size condition with the customer's (90mm)
- Catalyst change lead fluidity shift for about 50°C, and the problem was solved after lowering injection temp.

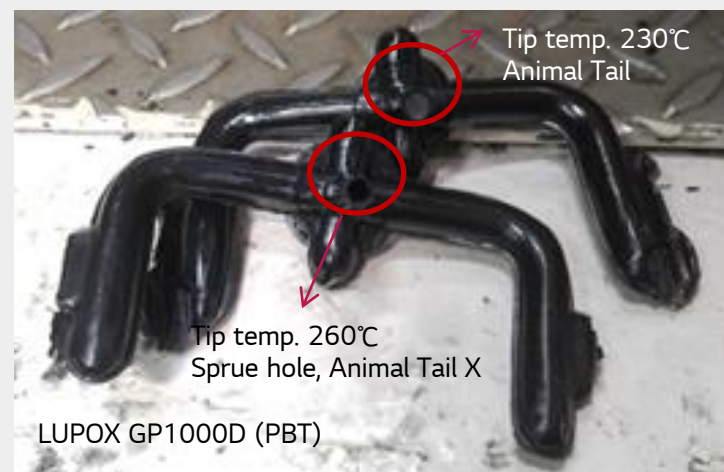
- Animal tail(string) defect near the HRS mold gate
- Affects the next shot due to contamination

- Lower the hot runner temp. and breaks tip :  
Lower 20~30°C (Should be adequate to prevent cold slug)
- Maintain tip melting by applying higher temp. :  
+30°C (Only change the tip temp. to prevent fluidity changes)

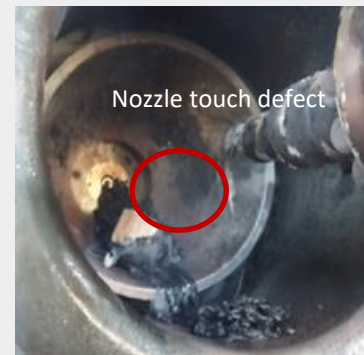
- Leakage in the nozzle touch part
- First shot is OK, but hard to inject from 2<sup>nd</sup> shot
- Leaked resin was found when the nozzle was separated

- Mold problem :  
Sprue Bush roundness and orifice phi error  
May vary depending on material properties  
(Easily found in high viscosity, high filler content materials)
- Free space of the nozzle touch lead leakage :  
Rapid cooling after leakage may cause defects
- Gets serious when drooling occurs

- Check sprue bush design and whether locate ring is damaged
- Adjust weighing condition (when not serious)
  - Prevent drooling (Set low back pressure, and excessive 2<sup>nd</sup> suckback)
  - Increase nozzle temp. (+20°C or more)
  - Use injection part retraction  
(Need to remove leaked material)
