How to Stop Flash

Flashing of a part can occur for several reasons—from variations in the process or material to tooling trouble.

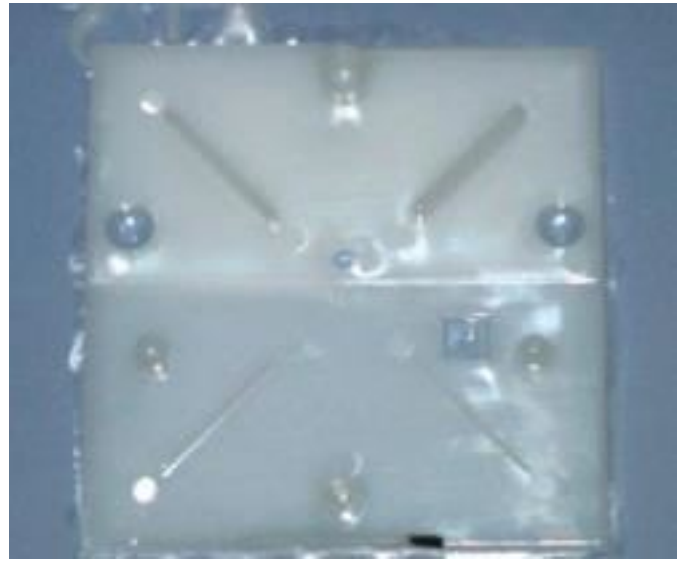
Flash on this part was traced to a filling problem. The cutoff or transfer point was incorrect, so too much material was injected. Flash occurred during packing.

Flash can occur during filling (first injection stage) or during the pack/hold (second stage), and it can occur with conventional parts and with thin-walled parts. Discovering in which stage flash occurs helps to reduce the complexity of determining the cause. A simple test is to bring the second-stage (pack/hold) pressure to the minimum the machine allows, which should be below 500 psi plastic pressure. The aim is to see the effect of just barely filling the cavity. First-stage injection fills 92% to 99.9% of the part, but this stage must end before the cavity is full. At the minimal pressure level for the second phase it is easy to inspect whether the part is a short shot at the end of first-stage injection. If there is flash on the short shot, we can focus on parameters affecting first-stage injection. If you don't get a short shot at all, then the answer may be to adjust the transfer point to avoid over-filling the cavity.
